Evaluation of Concrete Consolidation: DSS-35 Antenna Reinforced Concrete Pedestal Canberra Deep Space Communications Complex, Australia

Benjamin P. Saldua,* Ethan C. Dodge,† Peter R. Kolf,† and Carlton A. Olson†

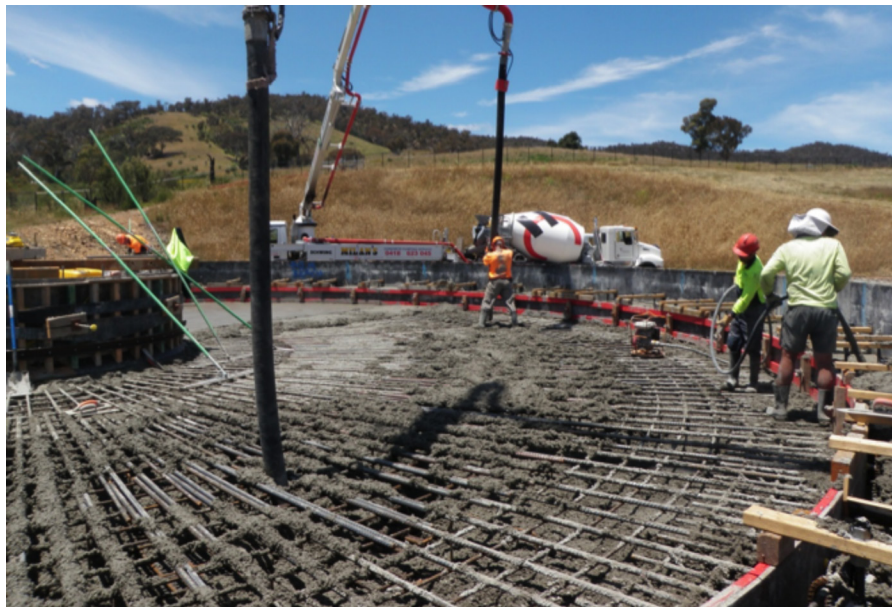
Figure 2. Concrete placement.

Concrete placement of the roof slab and outer track wall began by filling the outer track forms and adjacent main roof slab to approximately the roof slab final elevation and then continued from the center outward in wedge shaped sections (Figure 2). After the outer track had stiffened enough to be filled above the main slab elevation, the final layer was placed and the lifts vibrated together. Experience has shown that the most likely problem areas would be the lift line between outer perimeter lifts and below the lap splices of the upper and lower reinforcing mats in the roof slab. Poor concrete consolidation was visible at the roof slab underside below the lower mat lap splices at the time of form removal. These locations had been chipped to sound concrete at the time that the investigation commenced (Figure 3).
